DISCUSSION AND SOLUTION OF THE TBM TRAPPED IN THE WESTBOUND HSUEHSHAN TUNNEL

Chen-Chi LIN¹, Chi-Wen YU²

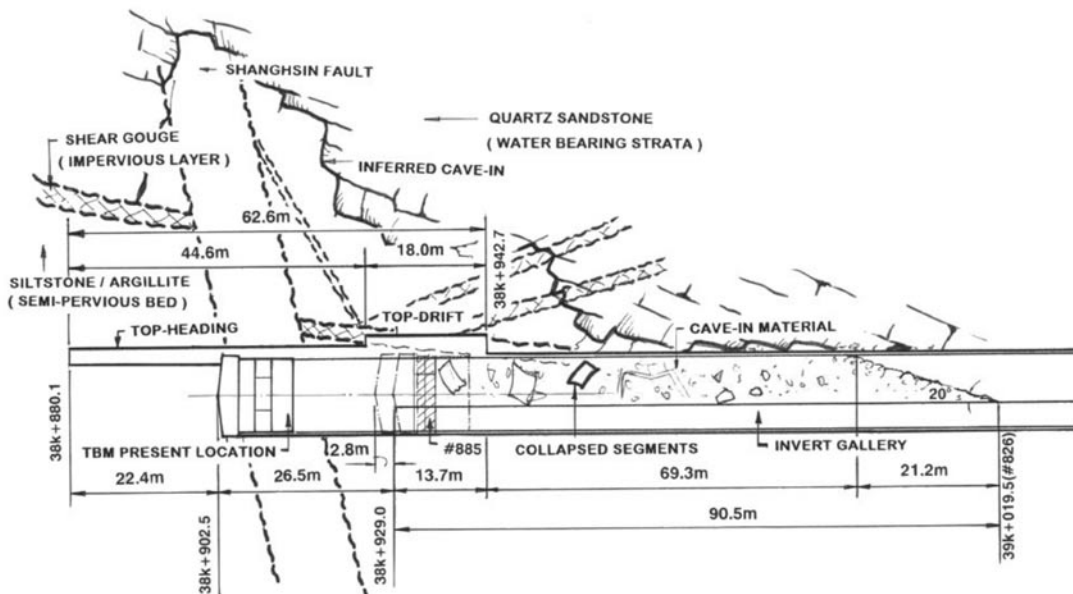
Fig. 2 Conceptual Geological Profile of the Stalled WB TBM

On December 10, 1997 the WB TBM had advanced Sta. 38k+902 as illustrated in Fig. 2. It was noted that serious deformation had occurred on the installed segmental supports adjacent to rear shield of the TBM, and the advance of TBM was suspended.

rear part of the TBM when the TBM advanced to Sta. 38k+902.5. The TBM excavation was halted immediately. The installation of H200x200 heavy steel rib reinforcement had been considered for locations which had major water seepage and had cracks in the installed precast segments. However, at 3 am on the next day, the existing cracks were getting wider and wider, and appeared in the crown segments and hillside segments between segment Nos. 885 and 886 (see

Fig.2). Tunnel squeezing towards the hillside was found to be associated with the unstable segments. By 8 am on the same day, water inflows had increased to 185 l/s, and the installation of the steel rib reinforcements seemed impossible. In the meantime, the tunnel squeezing had deteriorated towards the hillside.

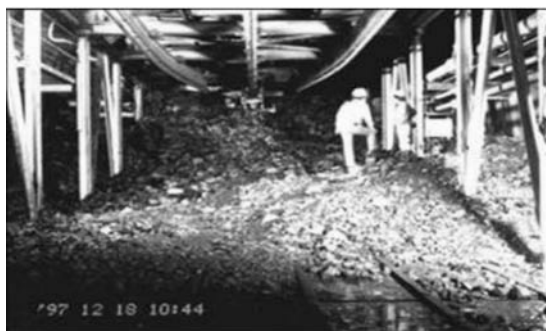
Photo 1. TBM Deeply Buried by Large Amounts of Debris after Inundation.

of groundwater inflow of 300 l/s that suddenly gushed into the tunnel. This sudden inflow was accompanied by sheared clay and rock fragments. The segments kept falling in a chain-reaction and the rate of water inflow increased to 500 l/s at 10 pm. As a consequence, the entire TBM was buried deep beneath large amounts of debris caused by the inundation. It was found that the watery debris which buried the TBM extended for a length of 90m towards the Toucheng end. Photo 1 shows the condition of the debris in the backup system behind the TBM. The actual length of the section with fallen segmental linings was unknown but the estimated volume of the cave-in materials might have reached 7,000 m³.

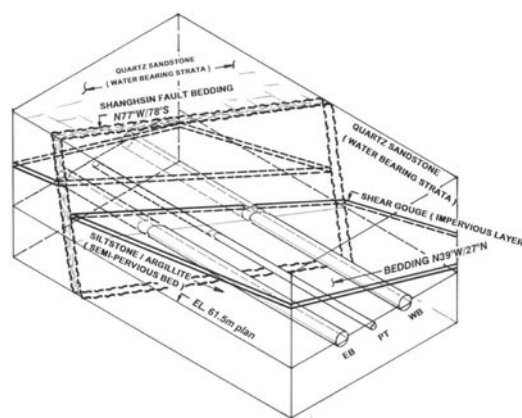
Fig. 3 Conceptual Structural Geological Model adjacent to Shanghsin Fault

at the southern flank of a regional anticline structure. Hence, flexural slip folding occurred commonly in the rock strata. Such flexural slip folding tended to form plastic sheared clay seams along the bedding planes and formed impervious layers which could block the water conductivity within the rock mass.

Before the construction began, the Shanghsin Fault had been recognized as one of the many important geological structures along the tunnel alignment within the Szeleng Formation. Its probable location within the Westbound Main Tunnel had been estimated through the Pilot Tunnel excavation. At the mishap area, the Shanghsin Fault was estimated to cross the Westbound tube at Sta.38k+915 to 38k+905 (central line, El. 61.5m). Rock masses beyond the fault zone were mostly riddled with shear fracture zones, thus forming a fault brecciated zone some tens of meters in width. The Shanghsin Fault extends at an attitude of N77 W/78 S towards both sides, and is a normal gravity fault in nature. The hanging layer at the Toucheng end of the tunnel, south of Sta.38k+915, slipped downward, while the foot wall north of Sta. 38k+905, at the Pinglin end, relatively moved upward, attaining a vertical throw of 8m. Fig. 3 shows a three dimensional block diagram in which the spatial relationship between the TBM and the major geological features are presented. The bedding attitudes of the sheared clay seams within the quartzose sandstone masses of the Szeleng Formation are rather gentle. It seems that the rock discontinuities did not appear to maintain regular frequency of occurrence, based on the investigation conducted in April 1997. That investigation revealed that the occurrences of shear clay seams in the foot wall of the fault, as well as

in the rock mass above the crown of the tunnel, were accompanied by water ingresses.

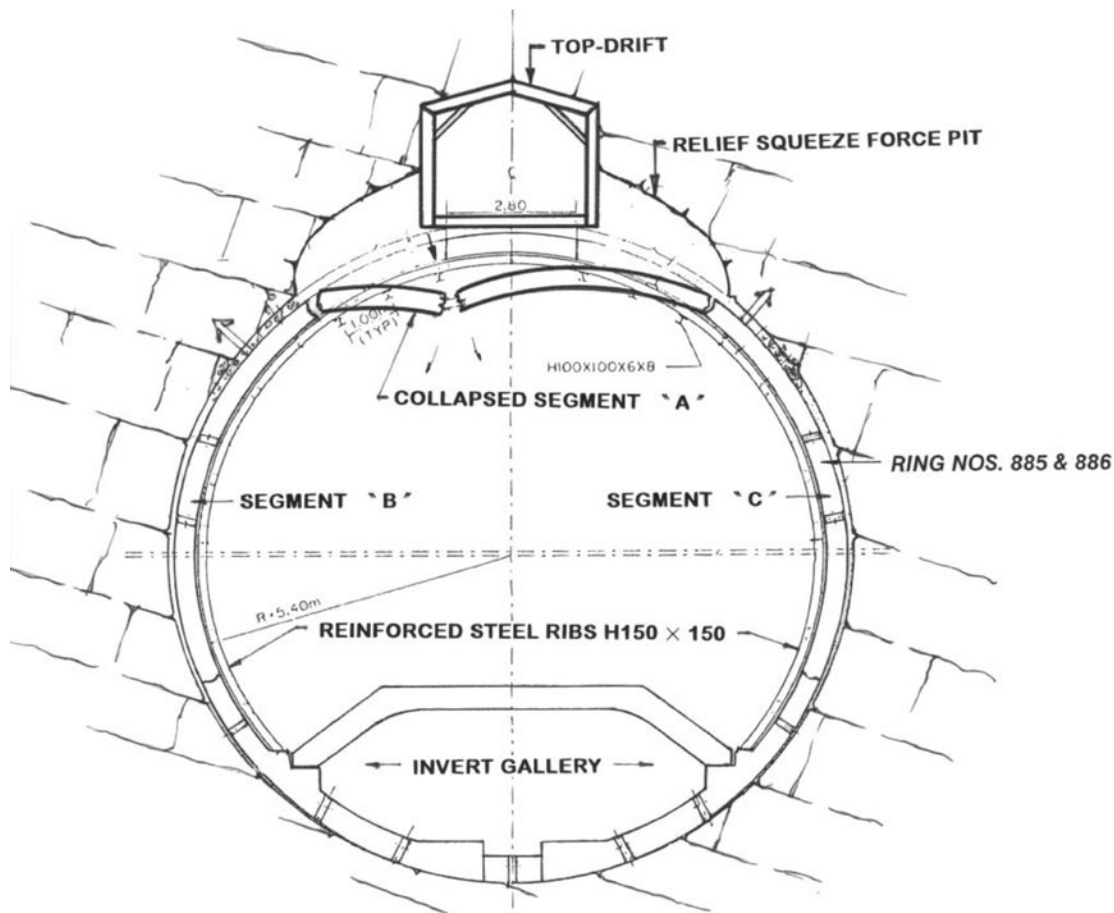
Fig. 4 Excavation by Top-drift

* The excavation of the top drift and top heading to free the telescopic shield lost support behind the crown segment as schematically shown in Fig. 4 and Fig. 5. The segment was, therefore, subjected to a stress condition different from the originally designed hoop compression load. Consequently, the structure of segment Nos. 886 and 885 changed from arch to beam. Since the bending stress exceeded the bending strength, cracks occurred causing the caving of the overburden rocks. In addition, several dozen segments failed due to the squeezing action from segment Nos. 886 and 885 that were supposed to provide lateral support to these segments. When a sufficient amount of cave in rock forms a volume plug, it will stop this domino effect.

No backfill for the 2.6m(H) x 2.8m(W) top drift to form confining pressure resulted in various loading on the segments. The actual circular strength did not function well and was prone to failure under stress (See Fig.4). When the invert of the top heading was excavated by the TBM, the rock pressure sustained by the top heading was transmitted to the lateral support footings. However, the support footings were again truncated by the TBM. Without any means of support, the tunnel rendered stress concentration leading to shear failure that caused the crown to cave in and groundwater to gush in (See Fig.5).
