## FAILURE MODES OF TBM AND REMEDIAL MEASURES USED IN THE HSUEHSHAN TUNNEL

Tain-Ying SHEN<sup>1</sup>, Por-Shin LEE<sup>2</sup> and Chi-Wen YU<sup>3</sup>

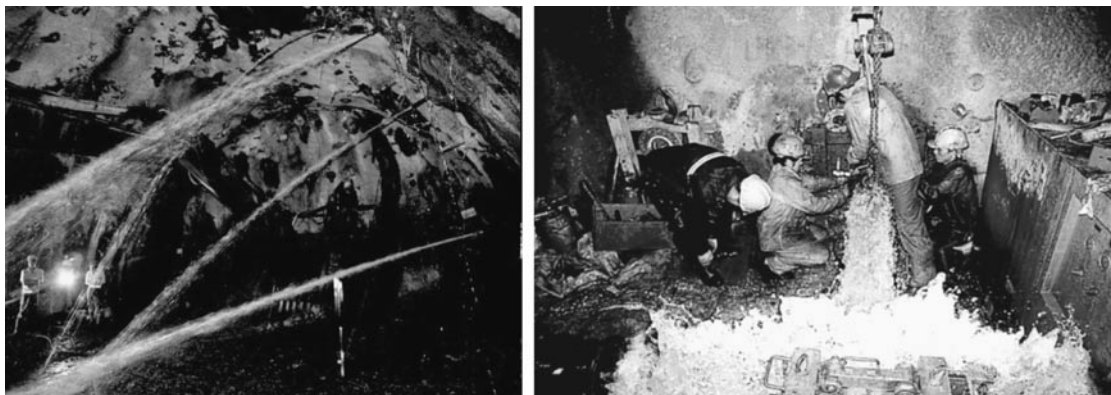
Fig.2 shows a conceptual groundwater model in which the groundwater conditions within the rock mass can be blocked by the sheared zones which can be rich in clay seams or fault zones to form a checker-like flow pattern. Adjacent to some major fault zones, high water concentration zones were formed in the rock mass due to the dense jointing with clayey shear zones. This formed a typical situation where the TBM would be seriously affected when passing through such a kind of rock mass. In most cases, when the TBM struck through the water aquifers which were confined by sheared zones or fault zones, large amounts of water rushed out all of a sudden and resulted in cave-ins adjacent to the cutter head of the TBM and jammed the machine thereby preventing it from free rotating. Photo 1 shows a local groundwater condition in the tunnel where pressurized groundwater was gushing out of the drilled holes.

Photo. 1 Groundwater Condition in the Hsueshan Tunnel

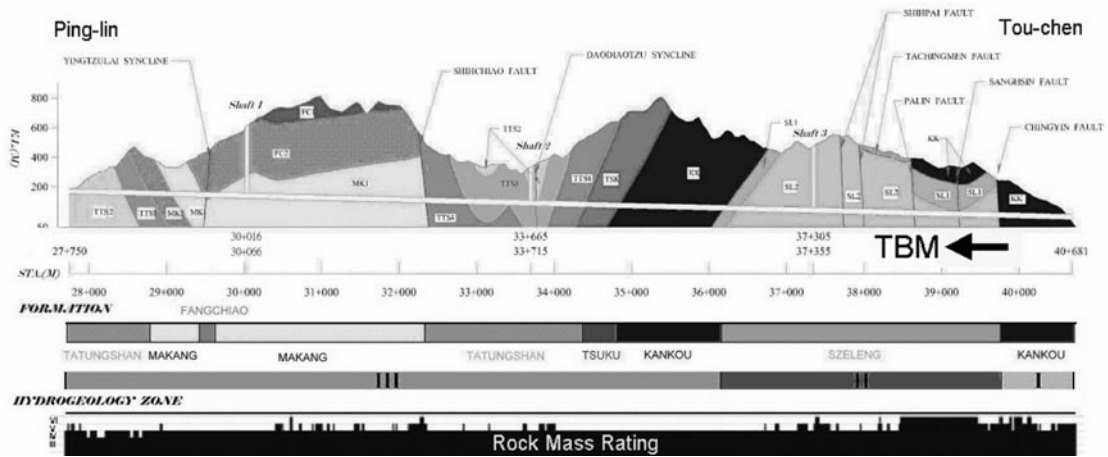
Fig. 1 Geologic Profile along The Hsueshan Tunnel

Fig.1 shows the geological profile of the Hsuehshan Tunnel. The rock formations along the tunnel alignment mainly belong to the Hsuehshan Range Geological Sub-province of Tertiary Age which is consisted of

gleaned during construction, 3 uniform groundwater regimes were identified. The locations of the three regimes can be seen in Fig.1 and their characteristics are summarized as follows.
