MODES OF GROUT TREATMENT ON GEOLOGICALLY INCOMPETENT ZONES, HSUEHSHAN TUNNEL

Lung-Chun CHANG¹

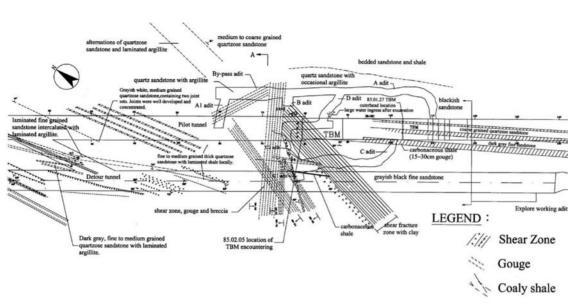
Figure 2. Plan View of the Geological Conditions around the 10th Stoppage of Pilot Tunnel TBM

Excavation of the Pilot Tunnel revealed that as result of the compressive action from the orogenic processes and faulting, besides the group of normal faults, there also occurred numerous sizeable shear zones with clay seams in the Szeleng Sandstone within the area. Joints are well developed in these shear zones. These joints are densely clustered and may show three or four sets of joint planes. The spacing of the joints is from 5 to 10 cm, with some as closely spaced as 3 to 5 cm. The openings of these joints range from one to several mm. Joints in rock formations in the area are in essence systematic. There are three major sets of joints, and they all incline in high angles. The attitudes of these joint sets are: J1: north-south striking (including NNE to NNW); J2: northeast by east; and J3: northwest by west. All three sets of joints possess load relief fractures, and the joint planes are mostly clay coated. In all, joints are well developed in rocks of the Szeleng Sandstone Formation. These joints occur frequently and are densely clustered, rendering the rock mass quality rather poor, and hence the rock mass possesses strong water storing capacity, and yet the rock is highly permeable. Groundwater is often hidden behind fault planes or stored in intercalated beds sealed off by clay seams. These groundwater bodies erupted into the tunnel as sudden, pressurized surges, and presented great difficulty in tunnel excavation and construction. The shear zones that occur at Sta. 39K+079, Sta. 38K+998 and Sta. 38K+934 all possess water stopping properties. These shear zones showed aggravated geological conditions worse than those of the other shear zones, rendering more difficulty in construction control. Figure 2 below presents the plan map of the shear zone at Sta. 39K+079. This particular shear zone caused the bogging down of the TBM in the main tunnel, as well as causing considerable difficulty

in the drill and blast construction. This happened when the drill and blast excavation circumvented, through bypass adit, to the corresponding position in the main tunnel. Grout treatment had to be performed before the groundwater influx was effectively stopped.

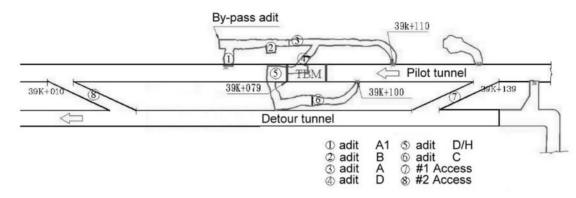
Figure 3. Plan for the 10th Stoppage of the Pilot Tunnel TBM

for excavating a bypass adit around the mired TBM to reach the front of the TBM.(Figure 3) And meanwhile, as the rescue works were in progress, tunnel excavation would proceed through the drill and blast method. This would be a flexible excavation method that would enable continuation of tunnel construction through the section underlain with Szeleng Sandstone and pressurized groundwater. It would also afford a chance to improve the adverse geological conditions of the ground. It was hoped that ground improvement would allow the safe passing of the main tunnel TBM and the freed pilot tunnel TBM, when these two machines reached this section later.

The outcropping rock formations between Sta. 39K+120 and Sta. 39K+080 belong to the Szeleng Sandstone Formation of the Oligocene age. From the bottom towards the top, these consisted of grayish white quartzose sandstone with occasional intercalations of argillite or coaly shale and bedded sandstone with occasional intercalations of argillite that showed laminated coaly shale or bedding shear. There were no signs of groundwater seepage. The TBM excavation proceeded normally and smoothly. However, although the inclination of the rock formations between Sta. 39K+080 and Sta. 39K+060 was at a low angle, due to the effects of an obliquely intersecting shear zone, the rock formations were sheared and fractured with thick intercalations of shear clay that sealed off groundwater behind them, and thus caused no seepage. Over a tremendous span of time, an immense quantity of groundwater accumulated behind the shear zone. Thus as the TBM operation broke open the shear clay that acted as a water barrier, a large quantity of groundwater

with rock fragments and clay rushed onto the TBM in the tunnel. After this first incident, considering the adverse geological situation at the site and the performance of the TBM, a detour tunnel running parallel to the Pilot Tunnel was excavated using the drill and blast method of excavation. However, as the excavation operation reached the outcrop of this same shear zone, an incident identical to the first one occurred again. A large quantity of pressurized water with rock debris and clay rushed into the tunnel. The influx was so strong that it was not possible to erect any steel support or shotcrete. Eventually, the ground had to be improved through consolidation grouting to stop the groundwater influx before excavation resumed.
