4 Maintenance Works

1 Maintenance Works

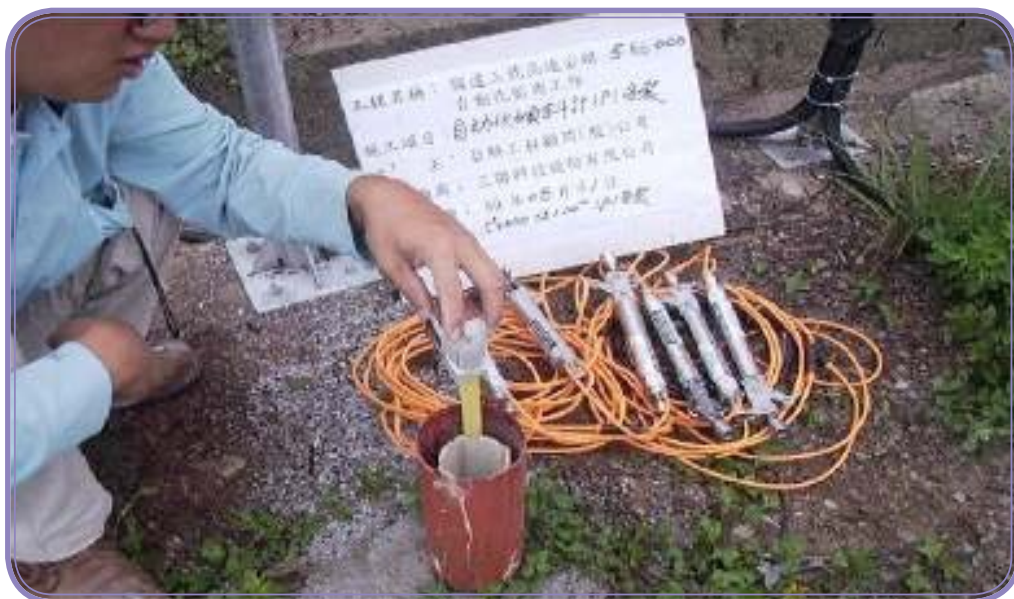
Fig. 2: Installation of automated and self-recording inclinometer.

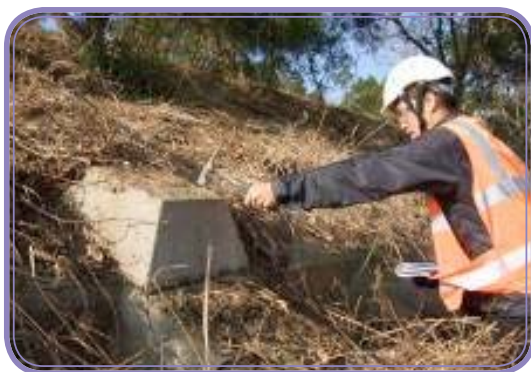
(a) Appearance check on the protection seat

Fig. 4: Examples of the Ground Anchor Inspection

Test	Content	Purpose
Appearance check of the protection seat	<ul style="list-style-type: none"> •Hammering •Visual inspection on the seat •Visual inspection on pressure plates and components •Connection inspection of pressure plates •Seepage check and water quality test 	<ul style="list-style-type: none"> •Inspection of the ground anchor appearance (including the seating, pressure components and seepage) •Corrosiveness
Anchor head components	<ul style="list-style-type: none"> •Head clip and steel rod corrosion check •Seepage check 	<ul style="list-style-type: none"> •Corrosion check of the anchor head components and seepage condition
Endoscope inspection	<ul style="list-style-type: none"> •Steel tendon corrosion check •Length measurement for the non-grouted section •Fall-apart and breakage check on steel tendons •Seepage condition at the free length section 	<ul style="list-style-type: none"> •Check the corrosion of steel tendons behind the anchor head, measure the length of non-grouted section, and understand the seepage condition.

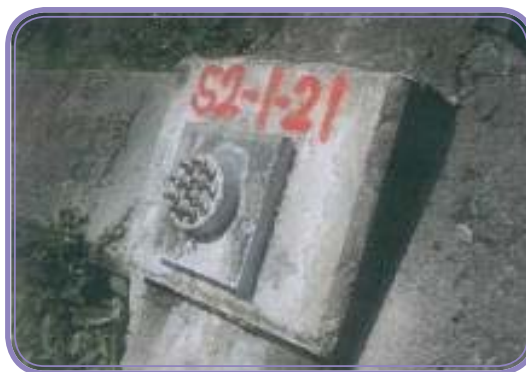
(b) Inspection on the anchor head components

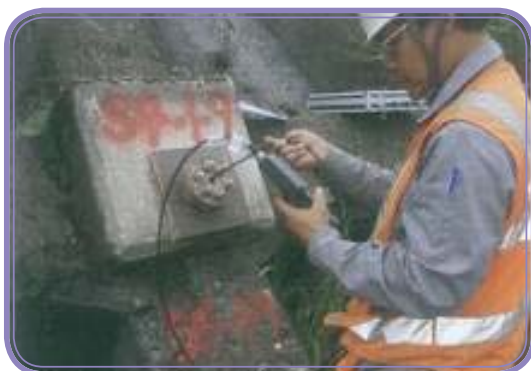
(c) Endoscope inspection

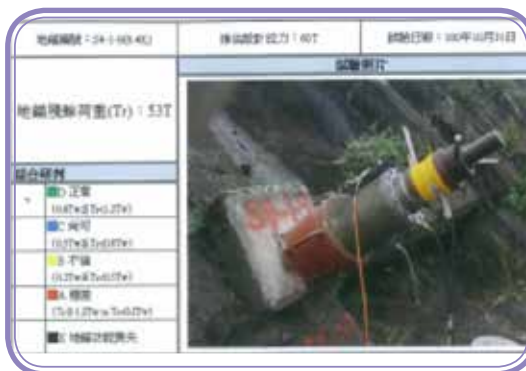
(d) Lift-off test

Lift-off test	<ul style="list-style-type: none"> •Measure the residual loading 	<ul style="list-style-type: none"> •Check the residual loading
