Introduction of National Freeway Bridge Seismic Design

- Nantou Section of National Freeway No. 6

Chen K. L.¹ Lou T. Y.² Hsu W.S³ Chan C.Y⁴

¹²³⁴Taiwan Area National Expressway Engineering Bureau MOTC

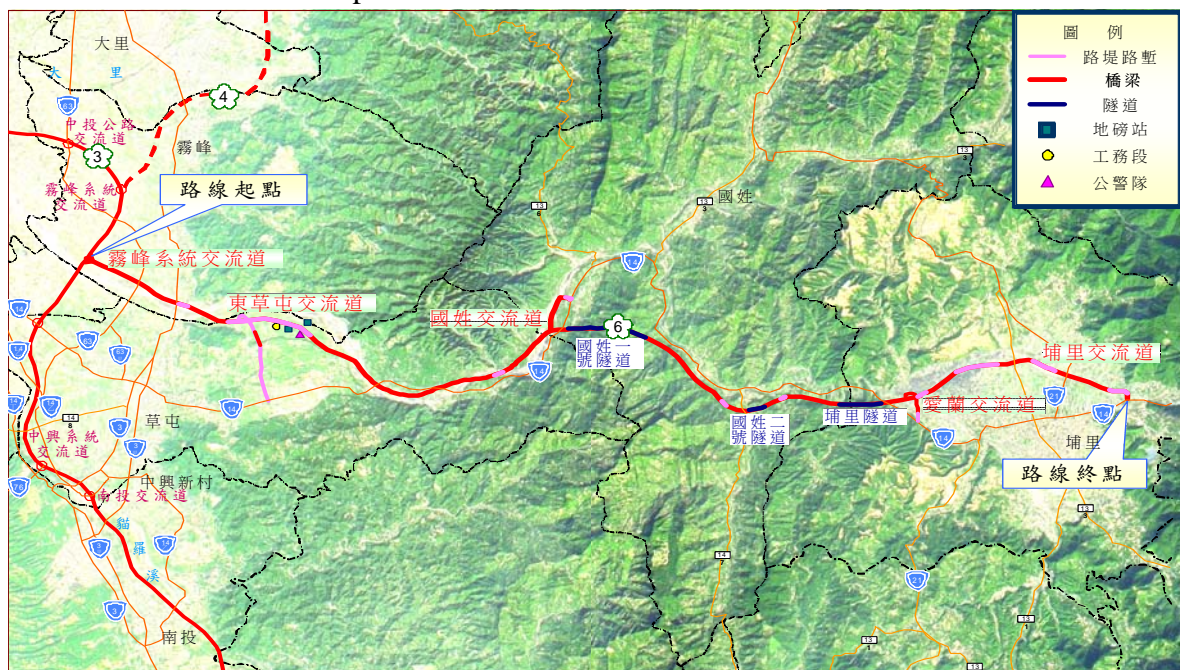
Figure 2 Location map of Nantou section of National Freeway No.6

Nantou section of National Freeway No.6 was designed after 921 Chi-Chi earthquake. The route started at National Freeway No. 3 Wufeng System Interchange in west, to eastern direction along with Wu Hsi, Nankung Hsi and Mai Hsi valleys, and mountain, Nantou County Caotun town, Guoshing township, then intersected to Provincial Highway No.14 in Puli town. The total length of the project was 37.6km. Viaducts and tunnels were designed with a smaller disturbance to the in-situ ecological. The route included embankment and open-cutting length 6.9km (19%), bridge length 26.4km (70%), tunnel length 4.3km (11%). (Figure 2) The whole project was divided into 9 lots (Lot C601 ~ C609). The construction began in 2004 and the main route was opened to service in March 2009.

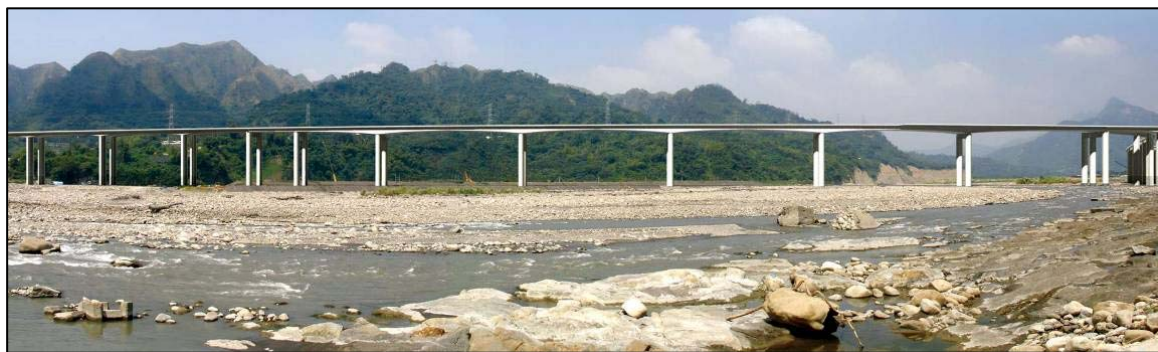
Figure 8 Elevation of Guohsing viaduct No.2

From west to east, the route layout was intersected third time to Shuangdong fault at $16K +800\pm$ roughly in 30° . The vertical alignment was up to 60m or more. And the fault was within the Wu Hsi stream channel management plan. Therefore, it could be passed only by bridges. Continuous steel box girder bridge (Guohsing viaduct No.2) in large span (span length in 150m) was adopted. The main idea was utilizing high strength and good ductility and light weight of steel beams to reduce the potential of the bridge collapse, and increase its survival rate under a major earthquake. (Figure 8~10)

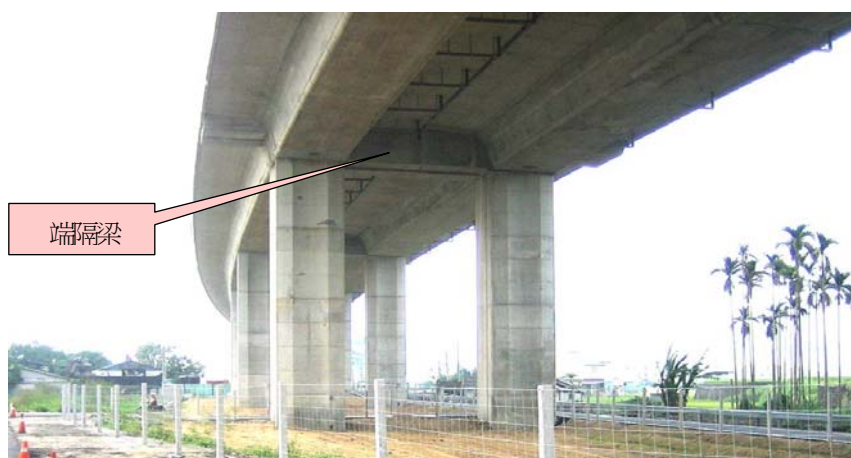
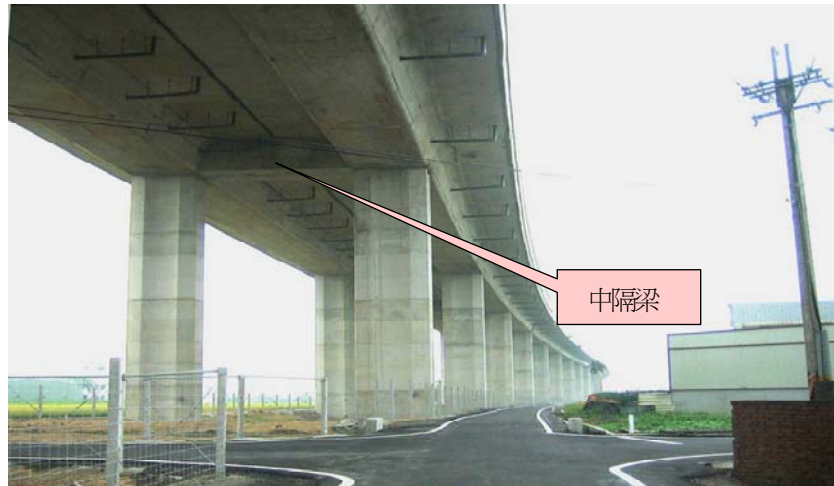
Figure 14 Elevation of full-rigid-frame type viaduct

This system were using horizontal elements (intermediate and end diaphragms) to connect the original separated two-way bridge on piers, thus forming the piers rigid frame structure in transverse direction. The structure system had a better redundancy which could reduce the lateral seismic force substantially. By reducing near-fault effect, the pier size could be smaller and the design difficulty could be lesser. Since the both direction of the

bridge structure were rigid, the structural system was called “Full-rigid-frame Structure”. C601 Nanwufeng viaduct was designed by utilizing the abovementioned concept (Figure 14~19). Since part of the piers of Nanwufeng viaduct were high, the piers already had a large ductility (large deformation) and LRB was inadequate in this situation. The full-rigid-frame system could reduce the size of pier under the influence of Chelungpu fault near-fault effect. The bridges that used full-rigid-frame structural system were shown in Table 2.

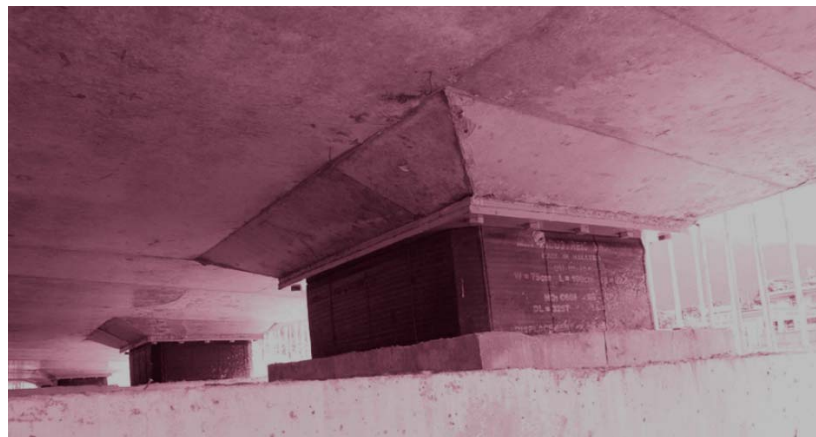
Figure 21 Photo of Lead Rubber Bearing

Lots C601, C607 and C608 of the project were using LRB because the near-fault effect of Chelungpu fault, and/or low vertical design alignment (average pier high $<10\text{m}\pm$). LRB could extend the period of bridge and lower down the design seismic force, so that the size of pier and foundation

could be reduced. The LRB bridges designed in Nantou Section of National Freeway No.6 were shown in Table 3 and Figure 21.

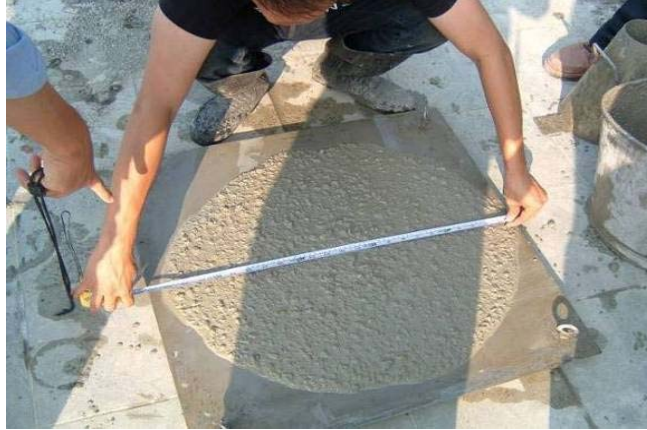
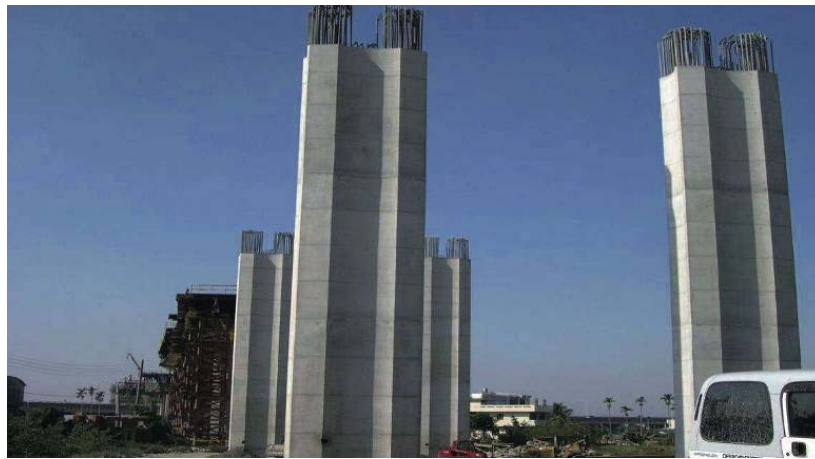
Figure 23 Photo of self-compact concrete, high slump

The SCC has the ability that "the pouring process without imposing any vibration tamping, the concrete can be completely filled reinforcement gap and all corners of the formwork by their own liquidity and performance". A larger amount of pier reinforcement was designed to meet the demand of seismic design specification. Densely arranged steel rebar caused concrete pouring work more difficult and led some casting quality problems. Some of piers was using self-compact concrete (SCC), so the concrete quality could fulfill the design needs (Figure 23, 24).
