# **INNOVATIVE SEISMIC STRENGTHENING AND ISOLATION OF BRIDGE STRUCTURES IN JAPAN**

Yukio ADACHI

Senior manager, Hanshin Expressway Co., Ltd.  
3-1-25, Ishida Minato-ku, Osaka, 552-0006 JAPAN

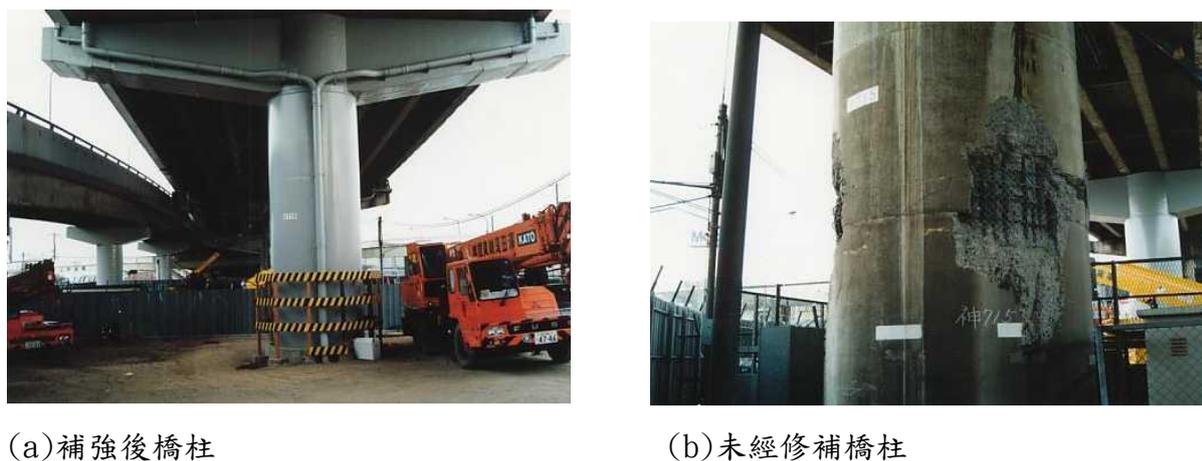
圖 1. 橋梁耐震補強效益的比較(1995 年阪神地震分析)

歷經西元 2011 年東日本的大地震之後，看見許多橋梁結構的各類損壞，最後也將橋梁受地震力破壞的災損歸納為三種造成的因素：第一是強烈的地表運動，第二類是海嘯所造成的損害，最後是土壤液化所造成的後果。值得注意的是，在這次的地震災害調查中顯示，對於高速公路所產生最大的破壞成因，乃是起於海嘯泛濫所造成的。雖然地表出現了強烈的運動，但是在經過 1995 年阪神大地震之後，許多橋梁已經成功地因為耐震補強而已有明顯地耐震力提昇，特別是阪神高速公路於災後的報告，顯示出補強之後的成效〔ADACH1997〕。圖 1 呈現了兩個高架橋，在經歷了 1995 年阪神大地震之後的反應，當時圖 1 左處正好是一座橋柱，是在 1995 年阪神地震發生前一個月剛完成了耐震補強工程，並未出現任何的災情。對照圖 1 右處則是另一座尚未完成耐震補強的高架橋柱，在歷經阪神地震之後卻產生損壞，如此可以看得出，在橋柱使用鋼板包覆圍束補強所造成提昇耐震力的效果是值得肯定的工法。而此類鋼板包覆工法，是以增加橋柱在柱軸向鋼筋接合處提高抗剪力的作法。

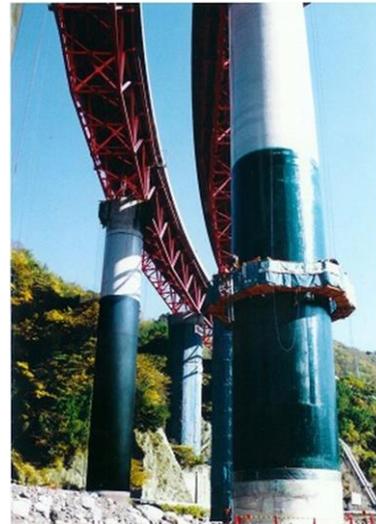
Figure 4. Carbon fiber jacketing method [OSADA et al, 2000]

Sheet jacketing using carbon fiber sheets or aramid fiber sheets, which are light-weight and need only relatively easy construction condition, have been applied to improve the shear and bending strength at

the section as shown in Figure 4.

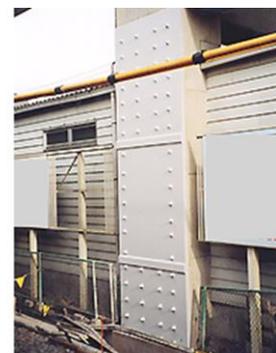
(c) Thin plate confinement method

(d) One side shear capacity enhancement method

Figure 5. New seismic retrofit measures for columns [JR East , 2014]

Currently, seismic retrofit of standard bridges designed accordance with old design specifications were almost completed except complicated bridges such that the bridges were built with subway stations or market stores. For the seismic retrofit of such structures, the most difficult construction requirements for retrofitting the columns are to accommodate the small construction space and limited construction time. In order to satisfy such requirement, the new seismic retrofit measures as shown in Figure 5 were invented by JR East Railway Company [JR East , 2014]. These techniques were also applied to road bridges.

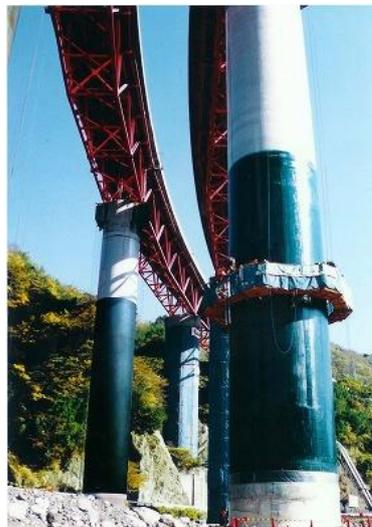
圖 4. 使用碳纖維圍束補強案例〔OSADA 2000〕

當施工條件許可時，使用碳纖維或玻璃纖維作圍束補強，也因著其輕質和易施工性，成為改善抗剪力及彎矩強度的工法，如圖 4 所示。

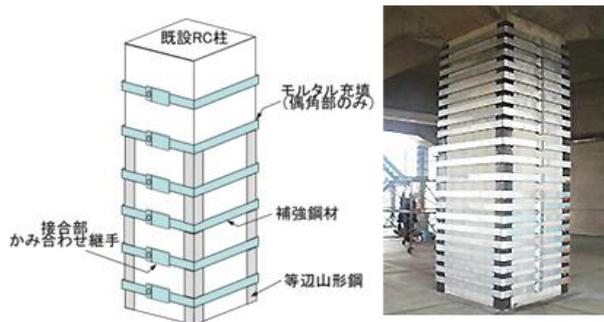
(a) 肋紋鋼條圍束補強工法

(b) 肋板圍束補強工法

(c) 薄板圍束補強工法

(d) 單側剪力增設補強工法

圖 5. 橋柱創新耐震補強工法〔JR East 2014〕

現階段舉凡所有依照舊設計規範條件標準橋梁的耐補強工作幾乎都告完工，僅剩下在地下鐵車站或是許多市場商店共構的橋。因為其複雜程度而尚未完成，對於這一類結構的補強工作，在施工時面臨最困難的條件，是如何在侷限空間內容納補強工程，並且其補強施工期也是受到限制的。為了滿足上述的條件，日本東鐵公司〔JR East 2014〕發展出許多創新的耐震補強工法，如圖 5 所示，這些工法同時也可以適用在公路橋梁的耐震補強工程上。

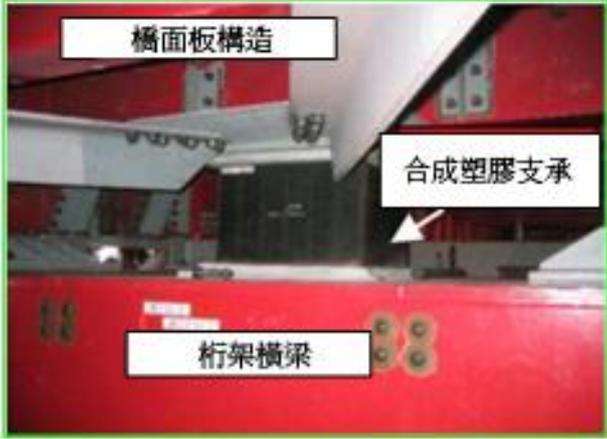
表三. 以橋面板隔震工法補強之長跨橋案例

<p style="text-align: center;">橋面板底梁</p> <p style="text-align: center;">滑動隔震支承</p> <p style="text-align: center;">垂直車行方向固定裝置</p> <p style="text-align: center;">摩擦面</p> <p style="text-align: center;">桁架構面</p>

<p style="text-align: center;">橋面板構造</p> <p style="text-align: center;">合成塑膠支承</p> <p style="text-align: center;">桁架橫梁</p>
裝置功能表現	<p>橋面板隔震系統包括：低摩擦係數滑動支承和多重橡膠支承，以調整橋面板的自然週期。</p> <p>只要透過橋面板隔震系統，將橋面板所產生的慣性力降低（增長自然週期原理），即可降低對於主桁架上斷面所產生的地震力反應。</p> <p>對於低摩擦係數滑動支承及多重橡膠支承的功能表現要求如下：</p> <p>(1) 低摩擦係數滑動支承</p> <ol style="list-style-type: none"> <li>① 支撐橋面板的垂直載重</li> <li>② 透過低摩擦力，降低由橋面板系統所產生施加於橋面板底部桁架的水平力道。</li> </ol> <p>(2) 多重橡膠支承</p> <ol style="list-style-type: none"> <li>① 調降橋面板於車行方向的自然週期，以達到對於橋面板底部桁架所施加的慣性力道。</li> <li>② 因為其線性的韌性特質，使得橋面板在地震力結束之後，使橋面板還原回復其原初始位置。</li> </ol>

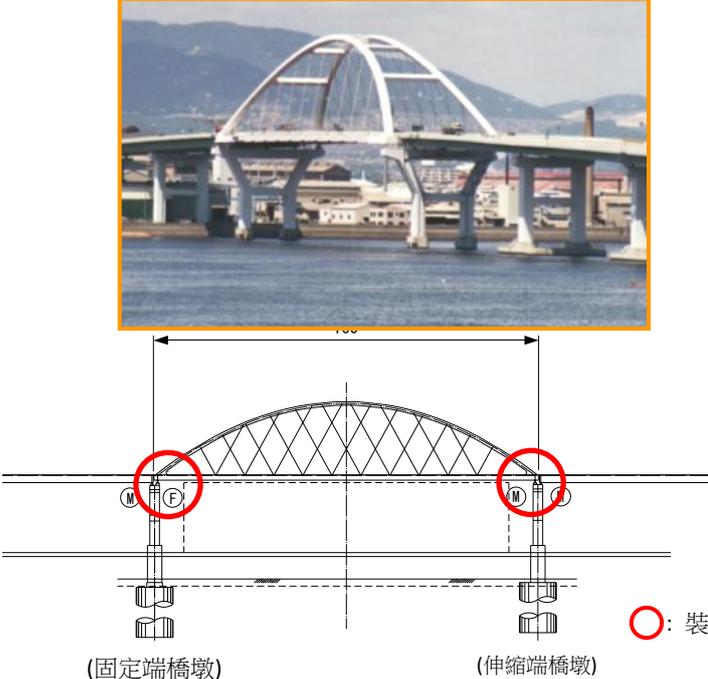
表五. SP 阻尼器應用於長跨徑橋梁耐震補強支承案例

<p>圖中上方為鋼拱橋的實景照片。下方為橋梁橫斷面示意圖，顯示鋼拱橋的結構。在橋墩與橋梁的連接處，分別標註了「(固定端橋墩)」和「(伸縮端橋墩)」，並用紅圈標出 SP 阻尼器的裝設位置。圖例說明：○：裝設處。</p>
裝置細節

<p>此圖展示了 SP 阻尼器在橋墩支撐處的詳細構造。圖中標註了以下部分：固定端、梁伸縮支承、翼板、基底、橋墩、空面圖、平面圖、Gap "e" Stiffener 和 剪力板。</p>
裝置功能表現	<p>SP 阻尼器在支承座的功能表現如下：</p> <p>(1) 於固定端</p> <ol style="list-style-type: none"> <li>① 在既有的固定支承一旦遭到地震力破壞之後，開始將上部結構因地震所產生的慣性力傳遞到橋墩。</li> <li>② 經由塑性變形所產生之遲滯阻尼迴圈以消耗能量。</li> <li>③ 將施加於固定端橋墩之水平力控制在可允許的範圍之內。</li> </ol> <p>(2) 於可伸縮端</p> <ol style="list-style-type: none"> <li>① 當上部結構所產生的慣性力超過固定端支承的容許承載限制時，荷載將由在伸縮端所設置額外的 SP 阻尼器承擔，所有裝置在固定支承及活動支承的阻尼器均能夠消能，減少對地震力的反應。</li> <li>② 將上部結構所產生的慣性力在容許的承載範圍之內，傳遞到可伸縮的橋墩。</li> </ol>

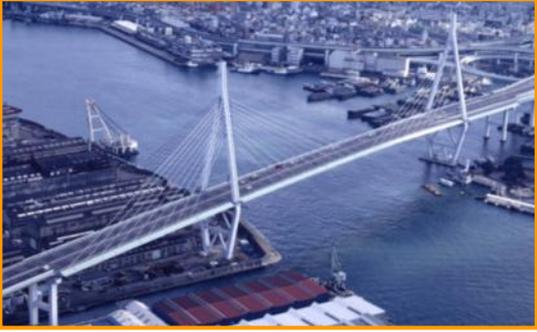
Table 6. Example of long-span bridge retrofit using SP damper application to gussets

<p>Cross</p> <p>Shear Panel</p> <p>Tower brace</p>
Device performance	<p>At the time of a seismic event such as the Level 2 earthquake, the compressive axial force will exceed the buckling strength of the braces. If shear panel dampers are installed at the gussets of the braces (SP damper at the gusset), the compressive axial force in the braces can be controlled within the buckling strength and the seismic inertia force of the superstructure can be reduced.</p> <p>Required performance for SP damper is as follows:</p> <ol style="list-style-type: none"> <li>1) To control axial forces acting on the braces within the buckling strength</li> <li>2) To dissipate the energy with hysteresis damping to reduce the seismic inertia force</li> <li>3) To control section forces of the columns and beams of the tower within the allowable values</li> </ol>

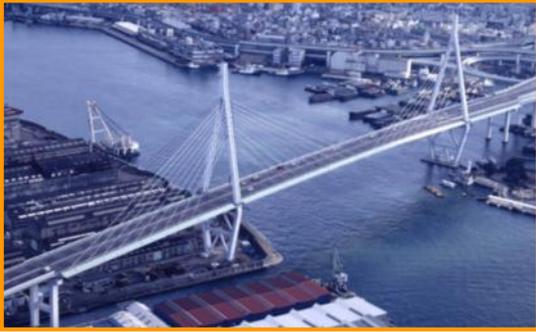
表六. 使用 SP 阻尼器於連接板的長跨橋梁耐震補強案例

<p>橫梁</p> <p>剪刀板</p> <p>主塔斜撐</p>
裝置功能表現	<p>例如在第二階層的地震事件發生時，軸向的受壓力將造成斜撐超過容許值而產生挫曲，若將剪力板阻尼器設置於連接板內，將可以使軸向的壓力控制在斜撐不致於產生挫曲的極限值之內，因此使得上部結構所產生的地震慣性作用力降低。</p> <p>剪力板阻尼器所需展現之功能表況如下：</p> <ol style="list-style-type: none"> <li>1) 將斜撐內所產生的軸向壓力，控制在產生挫曲的容許強度值範圍之內。</li> <li>2) 產生消能的遲滯阻尼，藉消能來降低地震慣性作用力。</li> <li>3) 將橋墩柱和懸索主塔的梁，所產生斷面上的力控制在一定的容許範圍之內。</li> </ol>

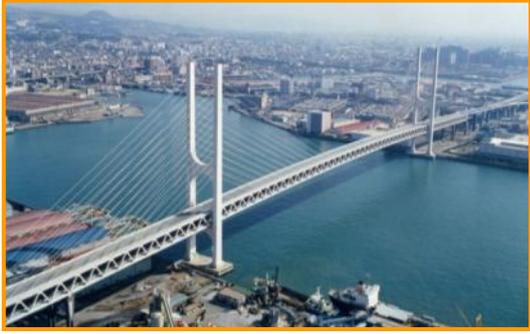
Table 7. Example of long-span bridge retrofit using displacement control device system with HDR damper

<p style="text-align: center;"><b>Displacement Control System with the HDR</b></p>
Device performance	<p>Control of longitudinal displacement using dampers is a very useful concept for all-free type cable stayed bridges. The displacement control system consisting of high damping rubber dampers (HDR damper) and connecting cables was adopted for the seismic retrofit of Higashi-Kobe Bridge. The performance requirement of the displacement control system with the HDR damper and connecting cables are as follows.</p> <p>(1) Performance of connecting cable</p> <ol style="list-style-type: none"> <li>1) To transfer inertia force of the girder to the HDR damper</li> <li>2) To absorb differential displacements in the vertical, transverse, and rotational directions between the girder and the tower.</li> </ol> <p>(2) Performance of HDR damper</p> <ol style="list-style-type: none"> <li>1) To provide supplementary damping to the structure to reduce the inertia force of the girder.</li> <li>2) To control the longitudinal displacement of the girder.</li> </ol>

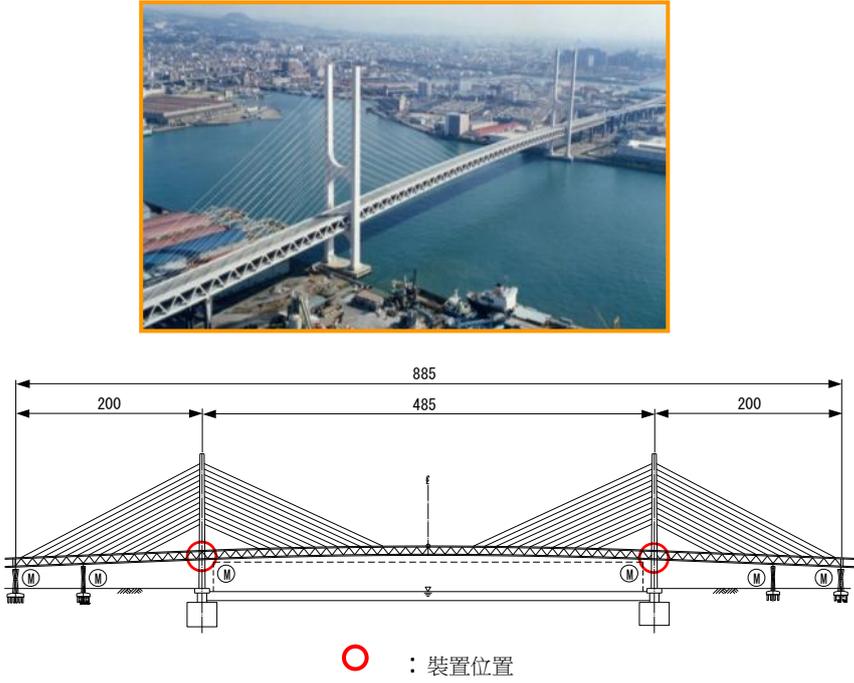
表七. HDR 位移控制阻尼器使用於長跨橋梁耐震補強案例

<p style="text-align: center;">HDR 位移控制系統阻尼器</p>
裝置功能表現	<p>對於多方向自由度的懸索橋體，使用車行方向的位移控制，是一個很值得思考的發展方向。位移控制系統是由高阻尼器的塑膠阻尼器，並且透過連接鋼纜所組成，在 Higashi-Kobe 橋耐震補強設計時所使用的工法，這兩項細節在地震力作用下，所需產生的功能表現規範如下：</p> <p>(1) 連接鋼纜</p> <ol style="list-style-type: none"> <li>1) 將梁所產生的地震慣性力，傳遞到 HDR 阻尼器。</li> <li>2) 吸收在梁與主塔之間垂直、橫向及旋轉方向不同的位移。</li> </ol> <p>(2) HDR 阻尼器</p> <ol style="list-style-type: none"> <li>1) 提供結構物額外的阻尼效果，以降低梁所產生的慣性作用力。</li> <li>2) 控制梁所產生的縱向位量。</li> </ol>

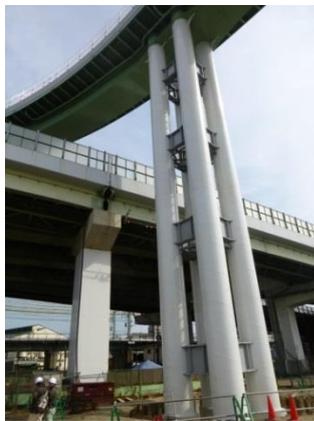
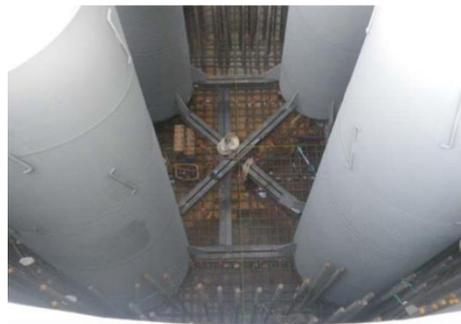
圖六. 中空鋼管與剪力板複合式橋墩

(a) 整體外觀

(b) 鋼管之間在基礎的连接狀況

一種創新型結合四枝中空鋼管，並由剪力裝置隨著高度連接而成形的橋墩，其中鋼管為主要結構體，作為承載垂直力（如自重和活重）系統，而剪力連接裝置成為次要結構系統，用於抵抗水平力（如地震力）。而損害控制的設計，便是在地震力作用之下，藉以保全鋼管並且減少橋墩的損害。如此一來，不僅是救災的緊急救難車輛，同時，一般民間所使用的車輛，都可以在地震發生之後，仍使用橋梁通行。甚至，即使因地震造成災損，但其重建復原的成本可以大幅降低，正因為主結構系統仍保持在一定的彈性範圍之內。圖六即為連接 Yodogawa-sagan 與 Kobe 兩地之間的 Hanshin 快速道路 Ebie 交流道上，一座最近完工的複合型鋼管橋墩。

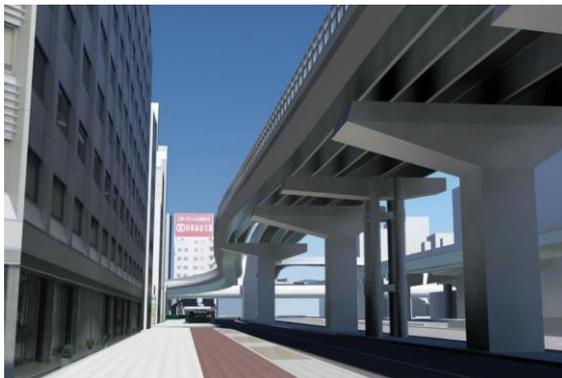
(a) 整體外觀

同樣的工法也應用在 Hanshin 快速道路的橋梁拓寬工程上，過去在橋梁拓寬工程的傳統設計思維，都以強化既有的橋墩，在增加橋墩及基礎因應拓寬部份所產生額外的垂直方向載重及水平方向的受力。但是常常因為都市的有限空間限制，並且地下空間也高度開發，對於既有橋墩或基礎的補強，幾乎是完全不能容許。就在 Nishi-Senba 橋拓寬工程案，這樣型式的橋墩，成為支撐額外拓寬段的自重，並擔負起全部水平力支撐系統，一種可在地震災損中犧牲的橋墩，圖七即為此橋墩的部份影像及設計概示意圖〔HORIOKA 2014〕。

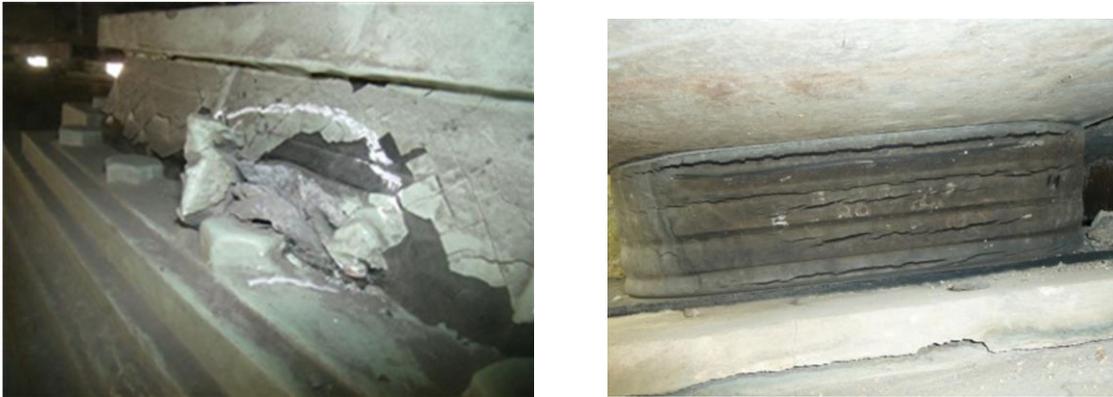
(a) Lead leaking out (LRB 17 years in-service) (b) Ozone crack (RB 27 years in-service)  
Figure 9. Typical aging damage of LRB and RB under service loading condition

In case of Hanshin expressway, approximately 32% out of total assets about 87,000 were replaced to laminated rubber bearings. Most of the rubber bearings were replaced after the 1995 Kobe earthquake. Some aging deteriorations were found in those bearing as shown in Figure 9. Figure 9(a) shows the lead leaking out from the rubber surface of the lead rubber bearing. Figure 9(b) shows the ozone crack found on the surface of the laminated rubber bearing. The remaining seismic performance of those damaged bearings was not clearly studied yet. In order to study the remaining performance of aging

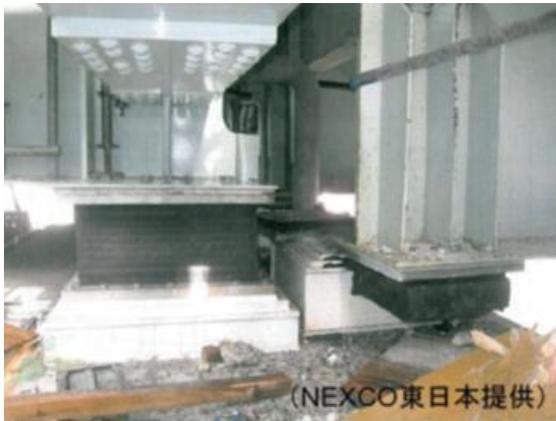
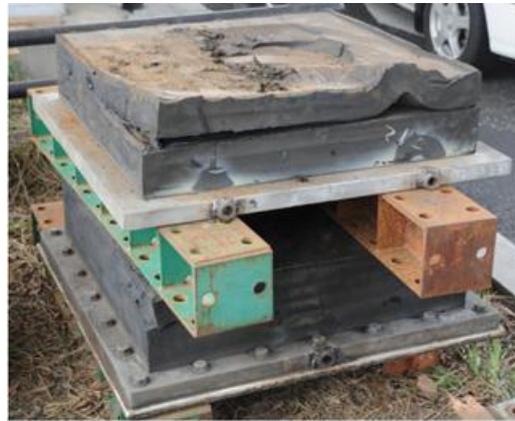
圖八. 2011 年東日本地震後所觀察到的損傷

(a) 因支承座受損造成梁的異位

(b) 受損後支承座之近照

但是在東日本大地震期間，橡膠支承座受到許多嚴重的損傷，圖八即顯示出在 Sendai 東路高架橋上，因為 2011 年地震所發生的橡膠支承座撕裂的損傷。撕裂就發生在橡膠層和鋼板夾層兩者黏合的間隙〔HIROSE 2011〕，這樣型態的損傷，不僅出現在地震力影響的情況之下，同時也在長期荷載的狀況下出現。

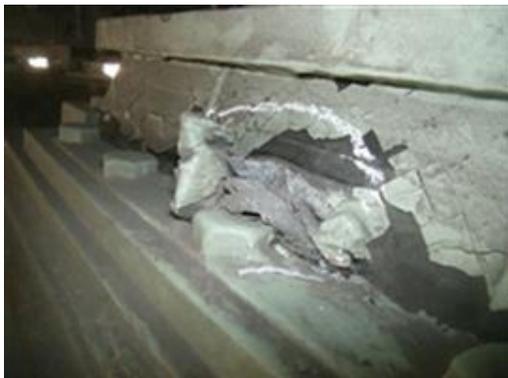
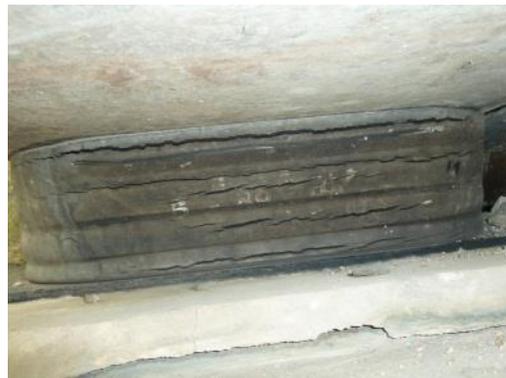
圖九. 在長期使用後鉛心支承座及橡膠支承座的劣化損傷

(a) 17 年使用後鉛的滲透

(b) 27 年使用期間暴露於臭氧環境所形成的裂痕

以 Hanshin 快速道路管理公司為例，所管轄總共約 87,000 座橋梁中，大約 32% 的支承座都已更換為橡膠支承座，而其中大部份是在 1995 阪神大地震之後所更換的。圖九可以看到許多老劣化的情形，在圖九左側 (a) 顯示在灌鉛支承座的橡膠表面已有鉛的滲漏，而圖九右側 (b) 的部份則是看出暴露於臭氧造成的裂痕，出現在橡膠合成支承座。而這些受損支承座，在地震力作用下的殘餘功能尚未被探討過，因此，為了研究老劣化支承座在殘餘壽命下，對地震力的反應表現，本單位特別將使用了 17 年的鉛心橡膠支承及使用了 27 年的橡膠支承座撤換下來，並且對支承座及橡膠材料本身的物理性質進行測驗。

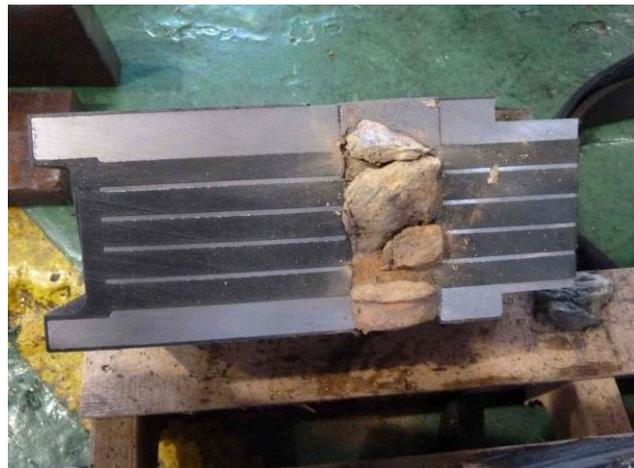
Figure 11. Fragmented lead plug of damaged LRB shown in Figure 9(a)

Figure 10 shows the horizontal cyclic loading test result of the LRB of 17 years in-service compared to the new product made by the old recipe of 17 years ago called “Reference” bearing [ADACHI et al, 2014]. The stiffness of the aged bearing was increased due to rubber hardening. This is the expected phenomenon. However, the hysteresis loop of the aged bearing shows much smaller compared to that of the reference bearing. This means that the energy dissipating capacity was drop or decreased due to the aging. These mainly reasons were considered of the damage of the lead plugs as shown in Figure 11 where the cross cut section of the tested deteriorated bearing was shown. The inside lead plug was completely fragmented and the colour of the lead turned to yellow due to oxidization.

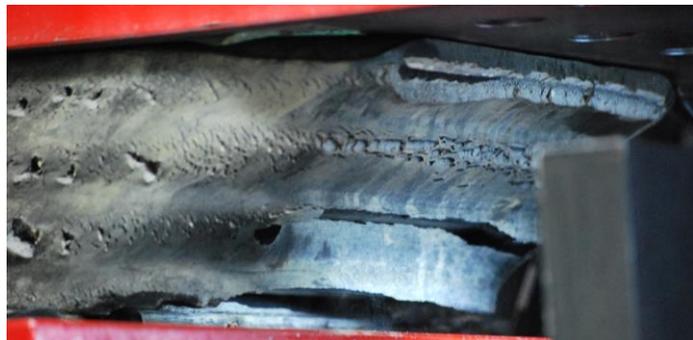
Figure 13. Ozone damaged elastomeric bearing

Figure 12 shows the horizontal push-over loading test result of the laminated rubber bearings of 27 years in-service compared to that of the “reference” bearing [ADACHI et al, 2014]. The strength capacity of the aged bearings was pretty small compared to that of the reference bearing. Figure 13 shows the surface of the aged bearings with ozone cracks. This result shows that the ozone deterioration might reduce the strength capacity of the aged bearings.

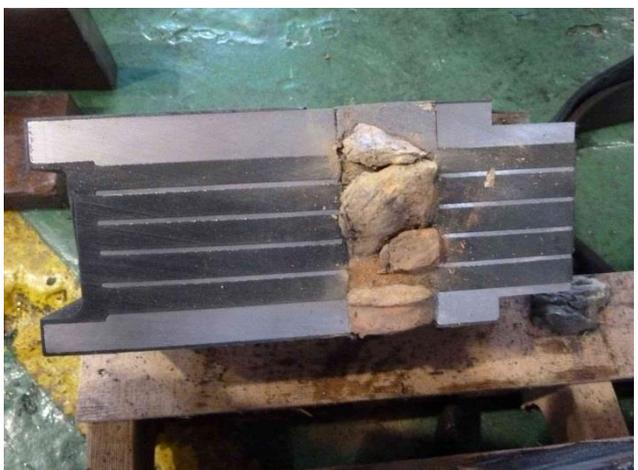
圖十一. 在圖九(a)中鉛心棒受損狀況

圖十展現出兩個支承座，在經過水平方向循環載重試驗之後的成果，其中之一是使用了十七年之後的支承座，對照相同的材料組合所製造的新支承座兩者之間的差異〔ADACHI 2014〕。老劣化的支承座因為橡膠材料的硬化而使勁度增加，這是可以想像的結果，但是老劣化橡膠支承座和對照組相比，其所形成的遲滯迴圈面積遠比新材料來得小很多，這表示老劣化支承座在消能的機制不斷下降，或是隨著使用年份而降低。在圖十一中展現了受測試的老劣化支承座在測試過後所切開的斷面，可以看出中心的鉛棒受損的狀況。其中的鉛棒已經完全的破碎化，並且因為氧化的原故，而使鉛呈現黃色。

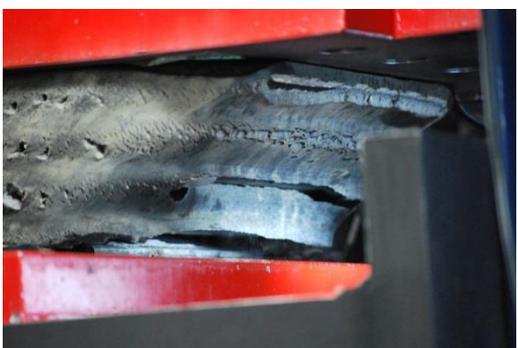
圖十三. 臭氧對於橡膠支承座的損害

圖十二顯示出在使用 27 年之後的橡膠支承座，在經過水平側推實驗與對照組相比較的成果〔ADACHI 2014〕。經與對照組在強度的比較下，劣化支承座的承載力遠遠小於對照組，圖十三呈現暴露於臭氧環境下，老劣化支承所產生的表面裂痕。這些結果都是印證老劣化支承座，受大氣臭氧環境影響，對於材料強度的弱化現象。
