DISCUSSION AND SOLUTION OF THE TBM TRAPPED IN THE WESTBOUND HSUEHSHAN TUNNEL

Chen-Chi LIN¹, Chi-Wen YU²

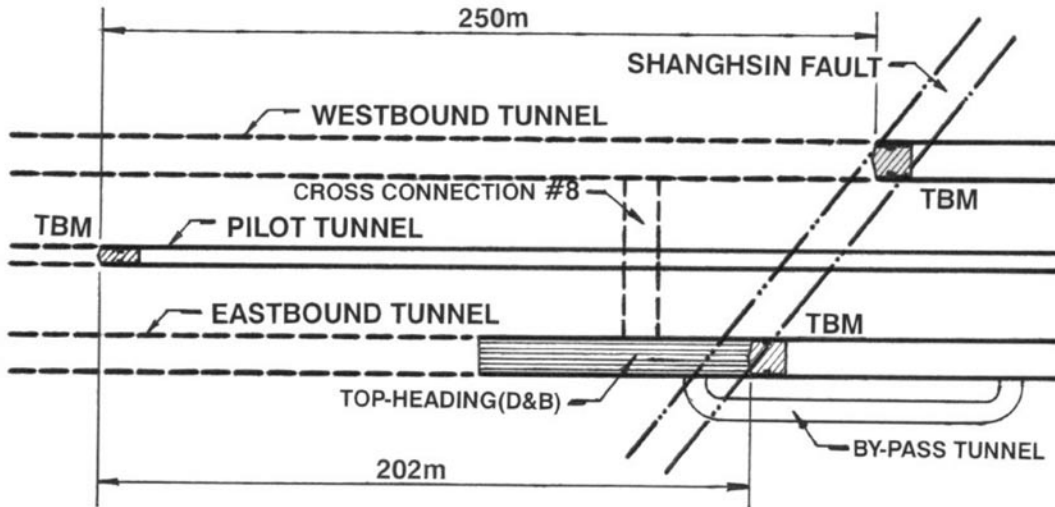
Fig. 1 The Layout of the TBMs adjacent to Shanghsin Fault (September 1997)

trapped in the Shanghsin Fault in the Szeleng Formation and remedial measures such as ground treatments and the construction of the canopy protections were carried out to ensure safety when the TBMs resumed their excavations. On September 6, 1997, the WB TBM reached the location of the Shanghsin Fault and the advance of the TBM was temporarily suspended in order to conduct ground improvement treatments prior to its recommencing. The locations of the three TBM are shown in Fig. 1.

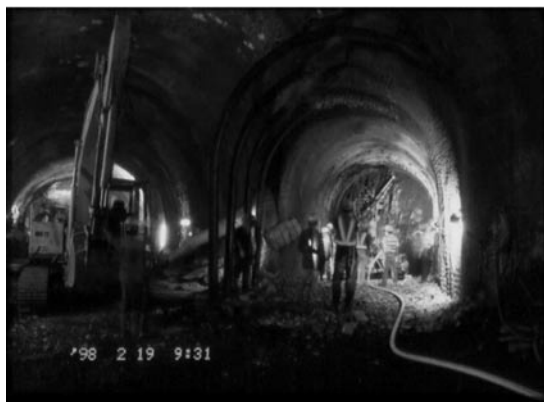
(a) Construction of Bypass Tunnel

The No. 8 vehicle cross passage was excavated by top heading (see Fig.6). Commenced on February 3, 1998 and completed on April 19, 1998, it accessed the face of the buried TBM via eastbound tunnel. This was finished ahead of schedule in order to have time to excavate the remaining Westbound Tunnel before the detour tunnel was completed. After completion, access for the excavations then shifted to the Westbound Tunnel to avoid the water-bearing zones being penetrated by the top heading again. The preliminary goal was to pass through the Paling Fault by short-bench excavation methods and rail haulage.
